TECHNICAL REPORT D-78-33

## HABITAT DEVELOPMENT FIELD INVESTIGATIONS, PORT ST. JOE SEAGRASS DEMONSTRATION SITE PORT ST. JOE, FLORIDA SUMMARY REPORT

July 1978

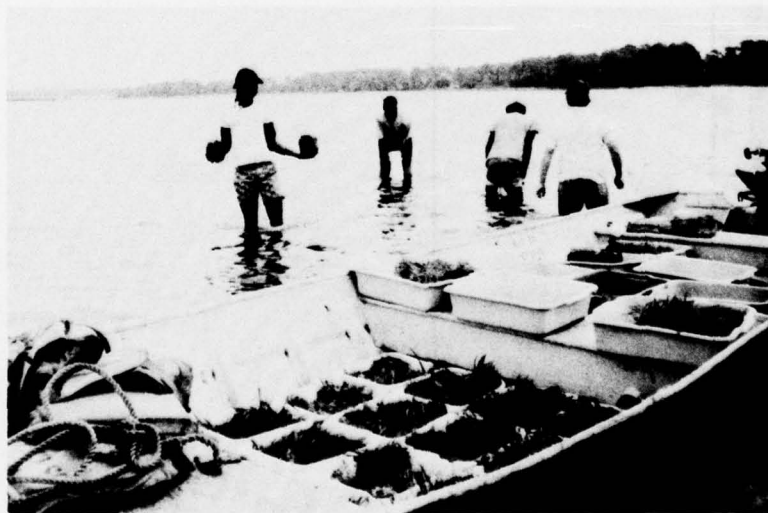
Figure 4. Plugs of shoal grass being removed and placed on boat for transfer to the planting site

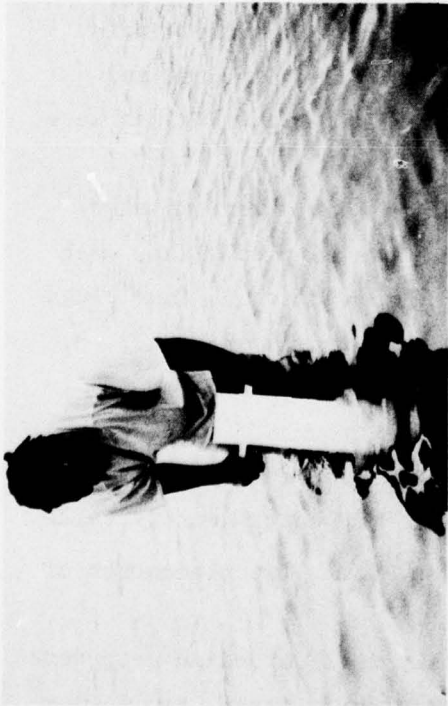
a. PVC coring device being used to remove plugs of shoal grass

23. Two different sizes and shapes of coring devices were used to obtain the 1488 plugs. For the 1242 smaller plugs ( $177 \text{ cm}^2$ ), a cylindrical 15-cm polyvinyl pipe, constructed at WES, was used. The 246 larger plugs ( $375 \text{ cm}^2$ ) were removed with a 15- by 25-cm iron frame rectangular corer. The rectangular corer was constructed by the senior author; the design was based on a similar device described by Ranwell et al. (1974). During coring, a shovel was used to carefully slice the plug and surrounding sediment free from the bottom sediment under the corer. The depth of coring by each device was about 15 cm and was sufficient to obtain the entire shoal grass rhizome, which generally grows to only about 7 to 10 cm.

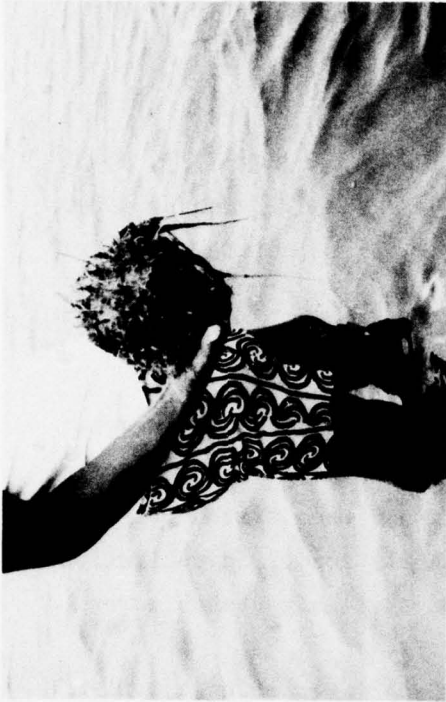
b. Plugs of shoal grass for transplanting onto dredged material substrate

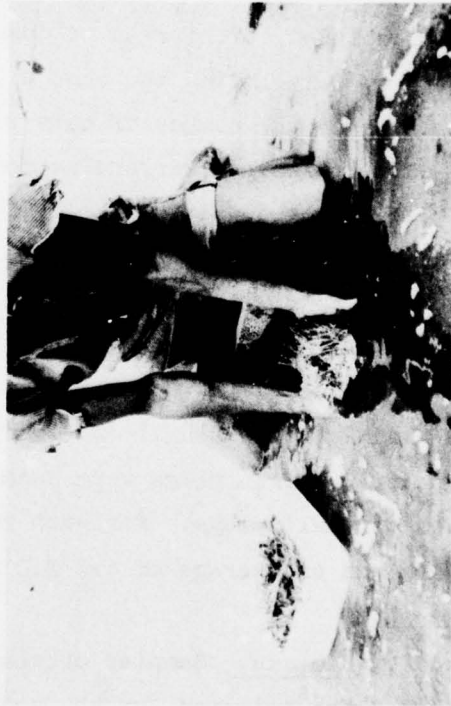
c. Plugs being planted into sandy dredged material

24. Following removal, the plants and original substrate were placed intact in plastic containers and transported by boat to the study plots. At the planting site, holes were dug in the dredged material to accommodate the two sizes of plugs. Figures 4 and 5 show photographs of the planting procedure. It took six men about 53 hours (318 man-hours) to obtain and plant the 1488 plugs. At this rate it is estimated that to plant one hectare with plugs at 0.9-, 1.8-, and 2.7-m spacings would require 2180, 555, and 250 man-hours, respectively.

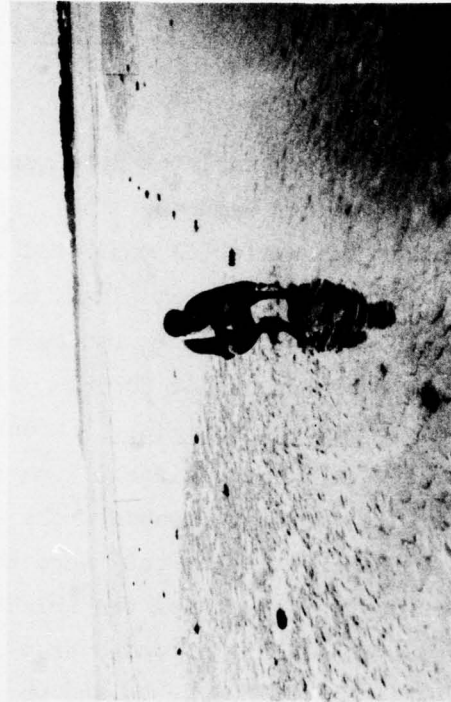
d. Inspection of plants planted on 3-ft centers

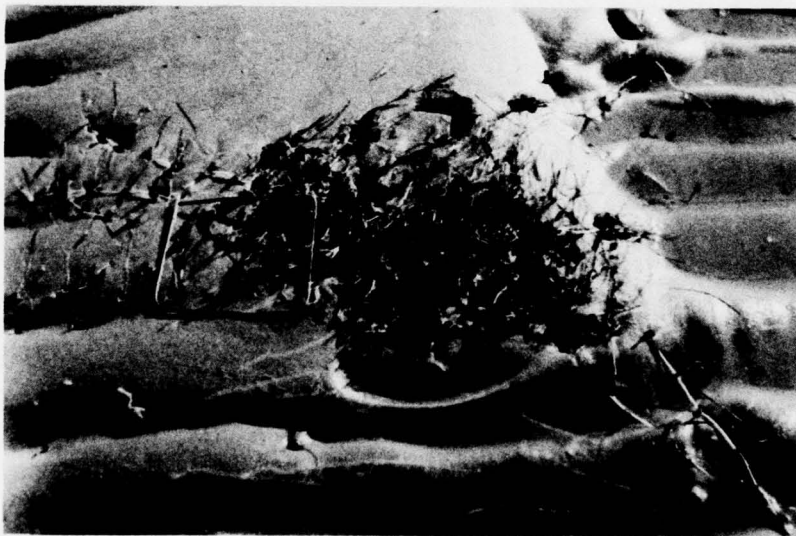
Photo 6 (sheet 2 of 2)

c. Large plug ( $375 \text{ cm}^2$ ). Note rhizome extension  
at lower right
